Manhole Inspection Summary

Manhole # S13II2020MH

Insp Date: **6/30/06 11:15 AM**

Location Address: **6205 SAREVA DR**

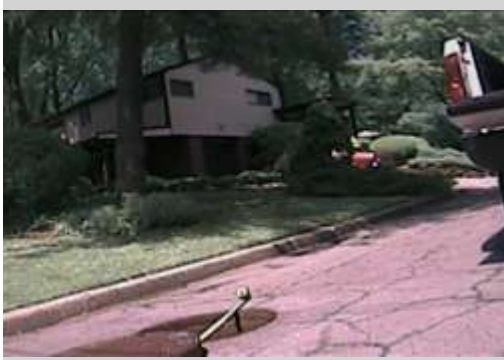
Location View

Comments **Cracks in the pavement around the manhole. Possible source of infiltration.**

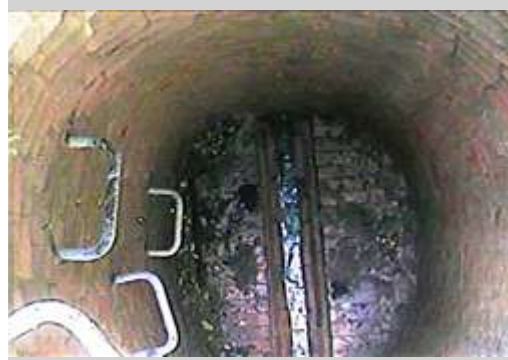
Top View

Infiltration: ☐ None ☐ Joint ☐ Cracks ☒ **Mortar** ☐ Roots ☒ **Wall**

Surcharge ☒ **Evidence Of Surcharge** Depth: **1** (ft.) ☐ Active Surcharge Present

Corbel and Barrel infiltration. Evidence of surcharge - Bench debris

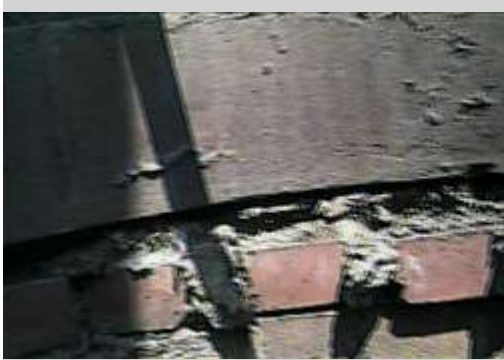
Defect

Frame Offset: **0** (in.) Condition: ☐ Sound ☐ Cracked ☒ **Leaks**

Condition: ☐ Sound ☐ Cracked ☐ Root Intrusion ☐ Loose Brick ☒ **Deteriorated**

Infiltration: ☐ None ☒ **Joint** ☐ Cracks ☒ **Mortar** ☐ Roots ☐ Wall

Frame leaks. Adjustment deterioration and infiltration.

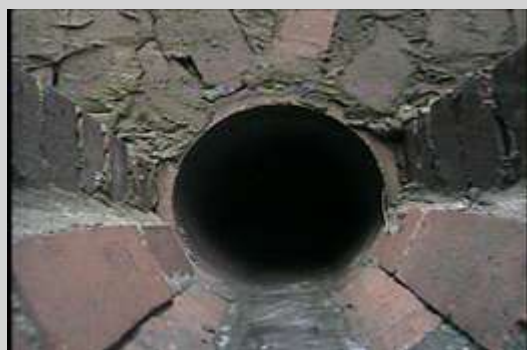
Pipe Out @ 12 O'Clock

Channel deterioration.

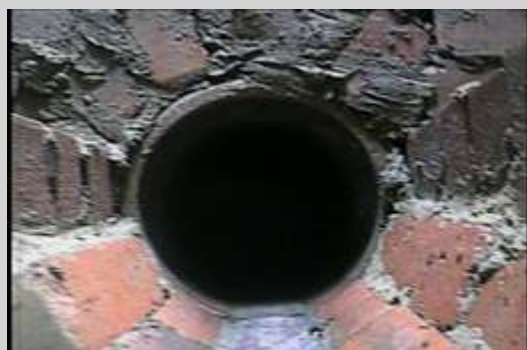
Pipe In @ 6 O'Clock

Infiltration: **Evidence** Pipe Seal Cond: **Unknown**
